ATTACHMENT A

(Motion for Approval of Cruise LLC's Offer of Settlement)

**MOTION FOR APPROVAL OF CRUISE LLC'S OFFER OF SETTLEMENT IN
RESPONSE TO ADMINISTRATIVE LAW JUDGE'S RULING ON MOTION OF
CRUISE LLC FOR ALTERNATIVE DISPUTE RESOLUTION AND DEFERRAL OF
THE ORDER TO SHOW CAUSE PROCEEDINGS**

Cruise regrets deeply the tragic accident that occurred on October 2, 2023 involving a Cruise autonomous vehicle (“AV”) (the “Accident”). Cruise also regrets that in the immediate aftermath of the Accident, it did not affirmatively tell the Commission that the pedestrian, who landed in the path of the Cruise AV after being struck by a hit-and-run driver, was dragged approximately 20 feet when the AV pulled forward to find a safe place to stop out of traffic in what is known as a “minimal risk condition pullover maneuver” (“pullover maneuver”). Cruise’s communications with the Commission in the aftermath of the Accident were not

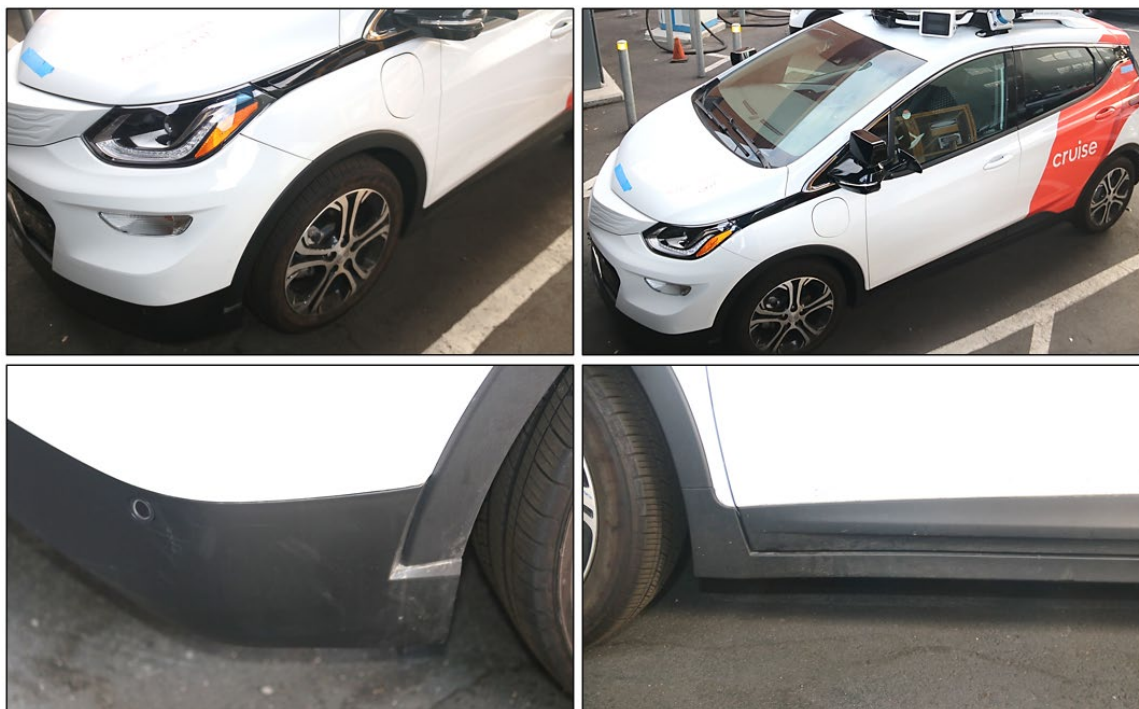
Figure 4. Photographs of the outside of the AV.

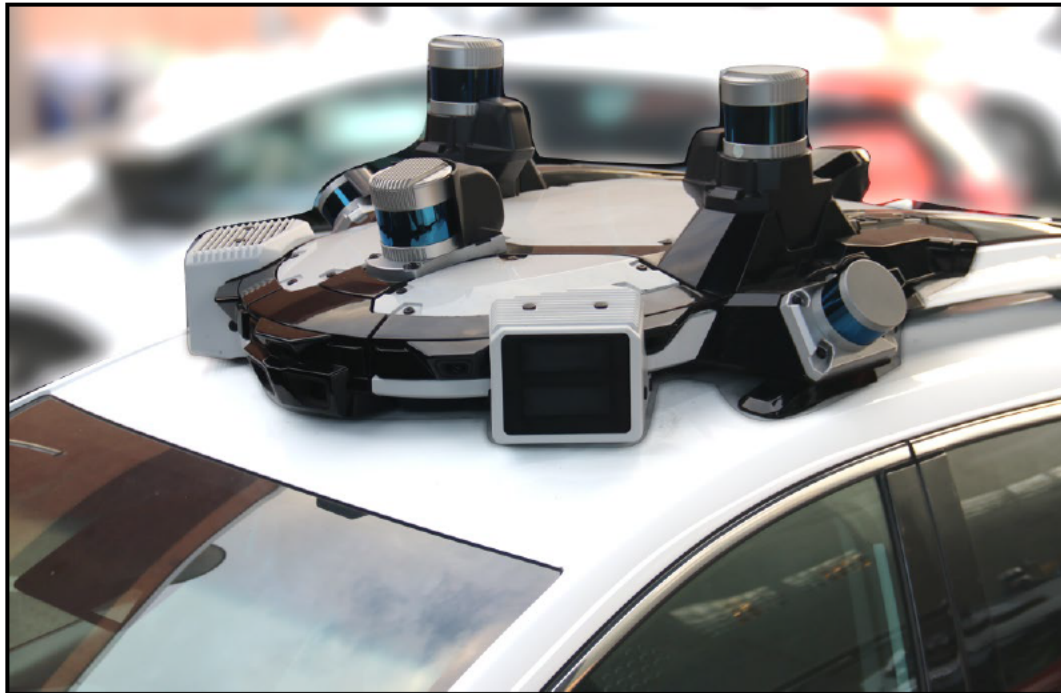
Figure 7. Roof mounted sensor array which includes lidars, cameras, and radars.
