AWWA PIPELINE REHABILITATION MANUAL

Rehabilitation of Water Mains

Third Edition

**American Water Works
Association**

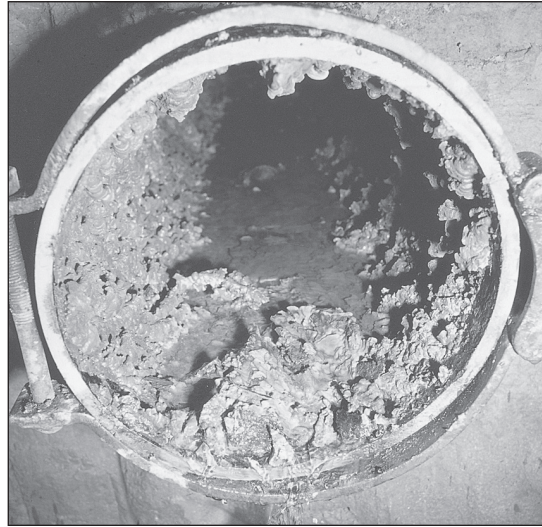
Figure 1-1 Pipe with tuberculation caused by corrosion

Scaling is the formation of hard deposits on the inside wall of the pipe. These deposits are frequently the by-product of pipe corrosion, wherein iron combines with calcium and other minerals within the water to form *tubercles*. The process, often called *tuberculation*, is assisted by bacteria within the scale that feed on iron leached from the pipe. Although scaling is most pronounced in cast-iron pipes, it is also commonly found in unlined steel pipes, copper pipes, concrete, and asbestos–cement pipes. Figure 1-1 shows a fairly typical tuberculated cast-iron pipeline.

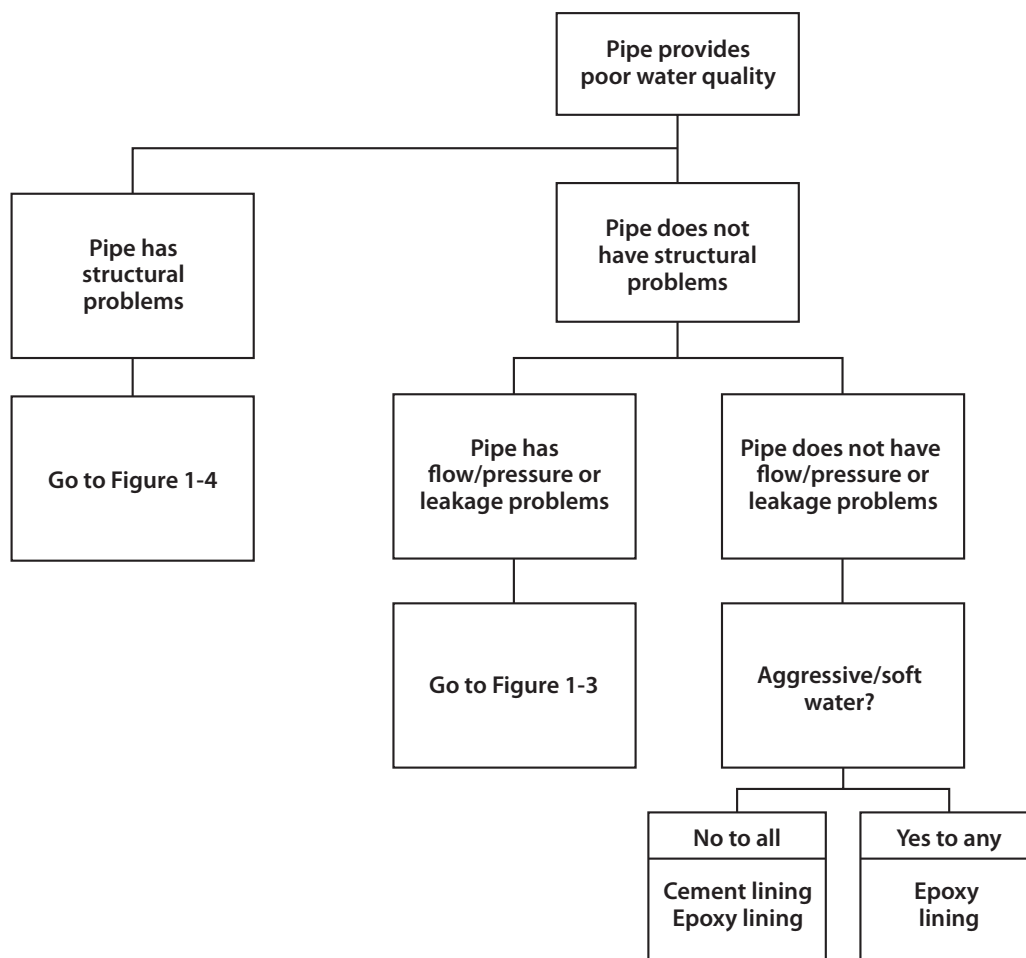
Figure 1-2 Selection of rehabilitation techniques to resolve water quality problems

One approach to rehabilitation method selection is summarized in Figures 1-2, 1-3, and 1-4. Together, these charts provide a framework for selecting or rejecting groups of rehabilitation methods, depending on the nature of the performance problems, hydraulic requirements, and some site-specific factors. In some cases, the charts indicate use of lining techniques classified as either Class I (nonstructural), Class II/III (semistructural), or Class IV (structural). A more detailed discussion of this classification system and of other key design issues associated with such lining techniques is presented in appendix A.

The figures do not list cleaning as a solution for water quality or flow and pressure problems. Cleaning with one of the various techniques discussed in the manual may well offer the lowest-cost immediate solution to many of these problems. It may offer a long-term solution if repeated as required or combined with chemical treatment of water to prevent or delay recurrence of the original problem. However, cleaning is more frequently used as a necessary preliminary step before carrying out one of the lining processes described in the manual.

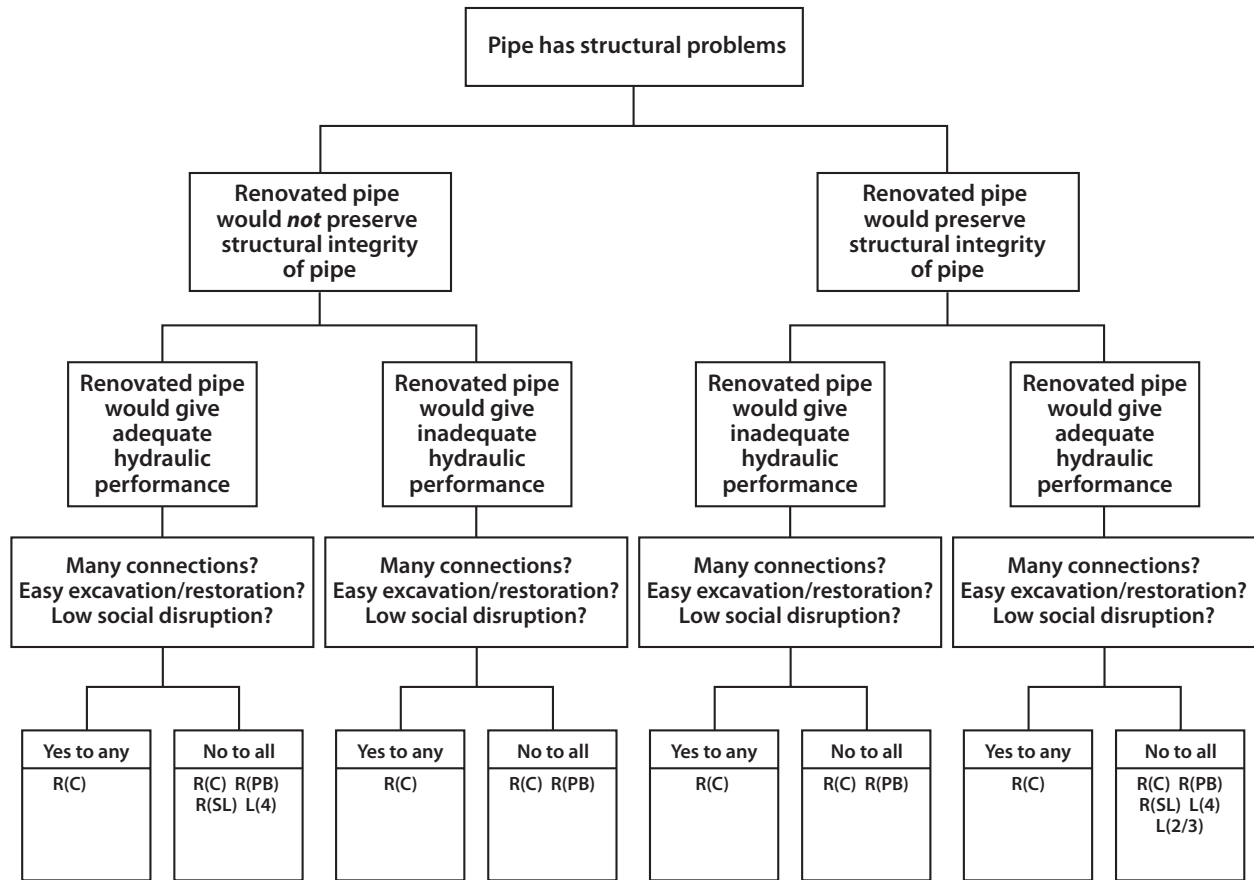
Notes:
 R(C)—Replacement (conventional or boring/directional drilling)
 R(PB)—Replacement (pipe bursting)
 R(SL)—Replacement (sliplining)
 L(2/3)—Lining (semistructural—Class II/III)
 L(4)—Lining (structural—Class IV)

Figure 1-4 Selection of rehabilitation techniques to resolve structural problems
